Karabiners *do* break!

Info Log - April 2014

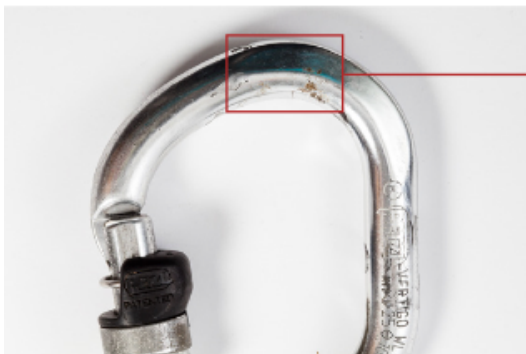
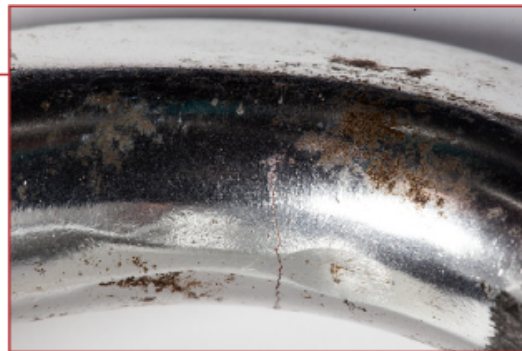
In ***three*** instances operators of Zip Lines in mainland Europe have reported VERTIGO Karabiners ***breaking*** in use. The breaks appear to be due to a combination of very small corrosion cracks appearing on the surface of the karabiner ***and*** the resulting effect of vibration during subsequent use.

The intensity of use appears to be significant. The potential for vibration fatigue to extend surface cracks within the karabiner appears to be increased through repeated use on very long zip lines. The environment in which the zip line is situated and specifically proximity to water and the sea in particular are likely to increase the potential for corrosion cracks to form in the first place.

In light of these incidents operators should consider the implications of such a failure and modify their practices, at least until metallurgists and designers can assess the wider implications, if any, of these specific failures. In particular operators should:

- 1. Ensure close visual inspection of trolleys *and* karabiners. This may mean dis-assembling the system/rig to some extent.**
- 2. Use additional safeguards. One option would be a back-up such as an additional sling and krab attached directly to the line, but there will likely be other solutions such as enhanced routine inspection.**

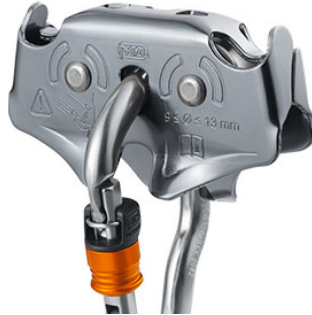
Initial surface cracks within the karabiner attached to the TRAC or TRAC plus pulley may go unnoticed as they form in the area of contact and are generally out of sight. (See below). Affected karabiners should be identified and removed.

Effective checking should include removing the karabiner to examine it closely.

The frequency of checks upon equipment should reflect use & environment.
